SWIMMING POOL AND RECREATIONAL WATERS QUALITY REPORT - 2025

MICROBIOLOGICAL ASSESSMENT OF SWIMMING POOLS AND
RECREATIONAL WATERS FOR THE NELSON MANDELA BAY
METROPOLITAN AND JEFFREYS BAY AREAS

BY: ASC Public Health and Food Safety Consultants

STUDY DATE: 12 December 2025

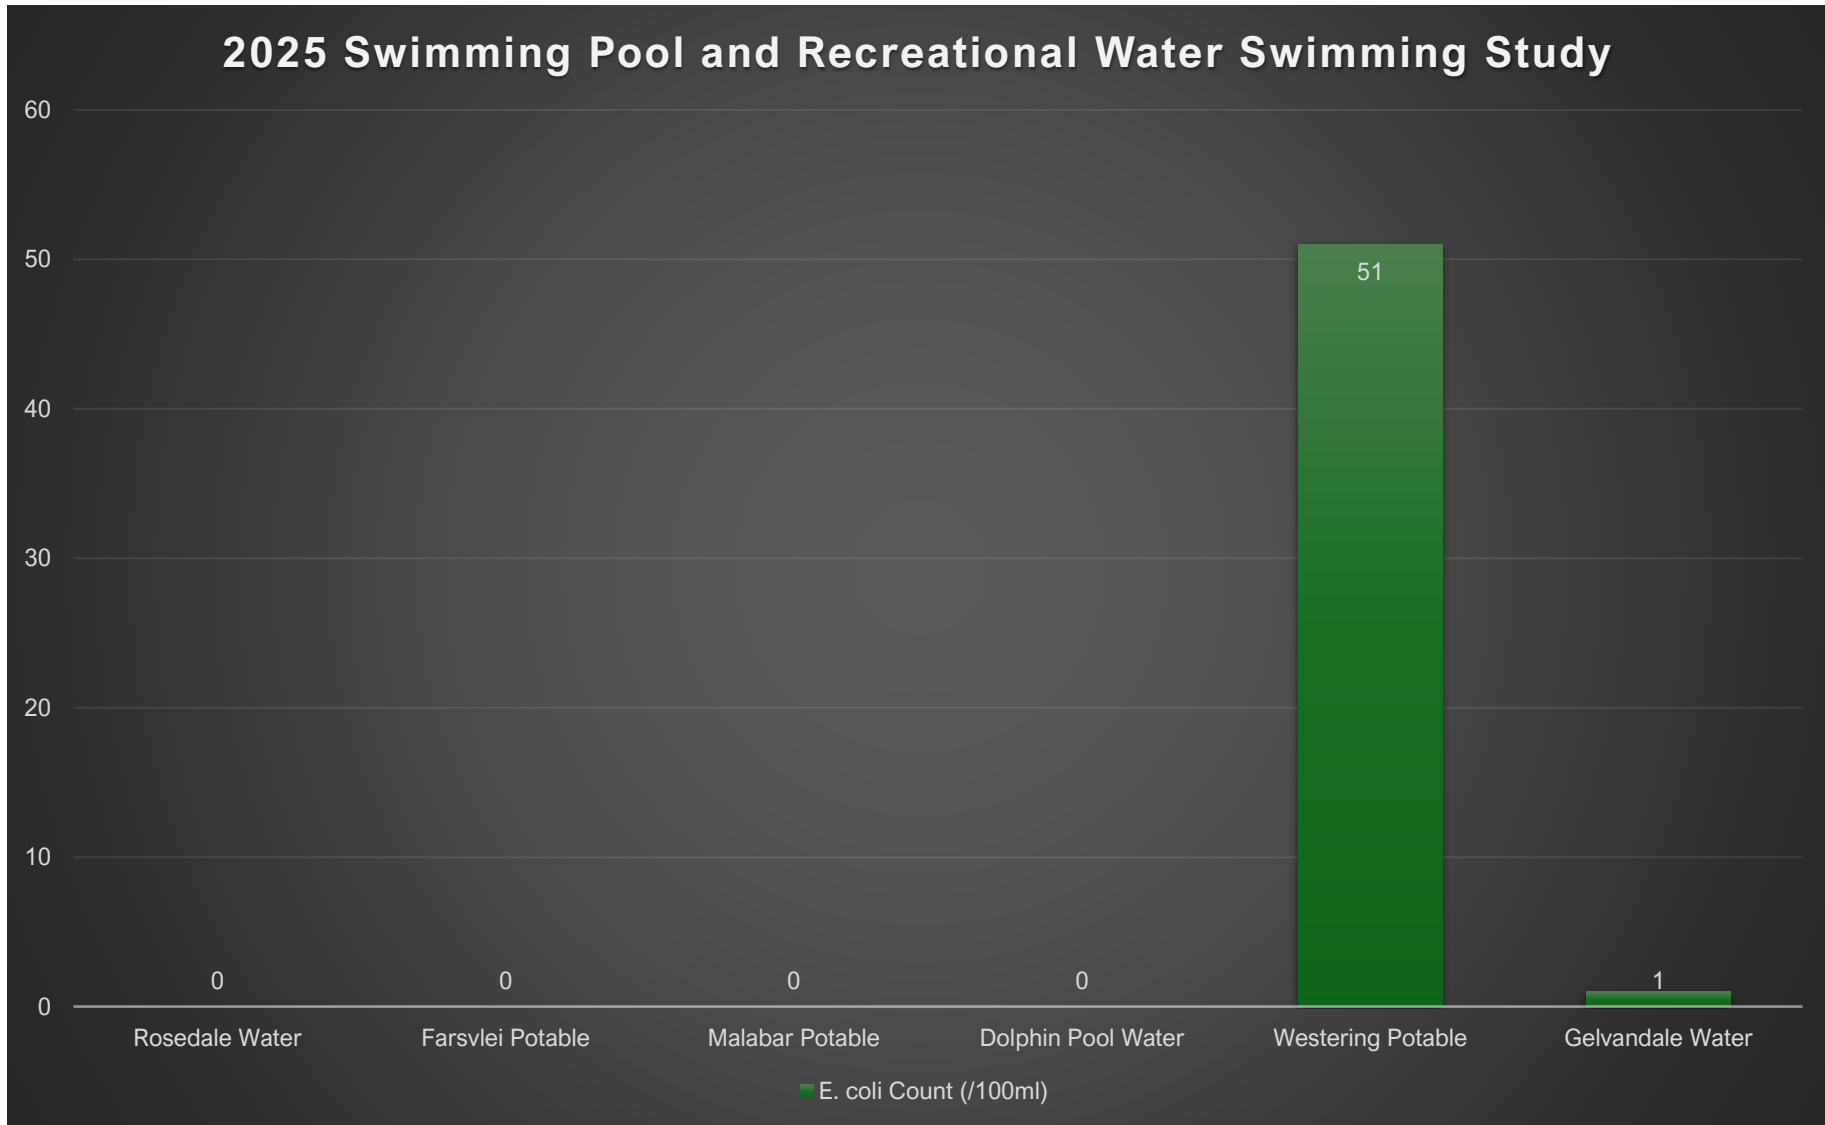
Figure 5: Clustered column graph analysis for E. coli.

This study showed a high number of waters contaminated by *E. coli* and exceeded the thresholds listed by the World Health Organization (WHO) in their guidelines. *Escherichia coli* are an indication of faecal contamination and a great health risk to the bathers. On the other hand, a detection of total viable count serves as an indicator of insufficient disinfection, a key risk factor highlighted in WHO Chapter four for microbial hazards.

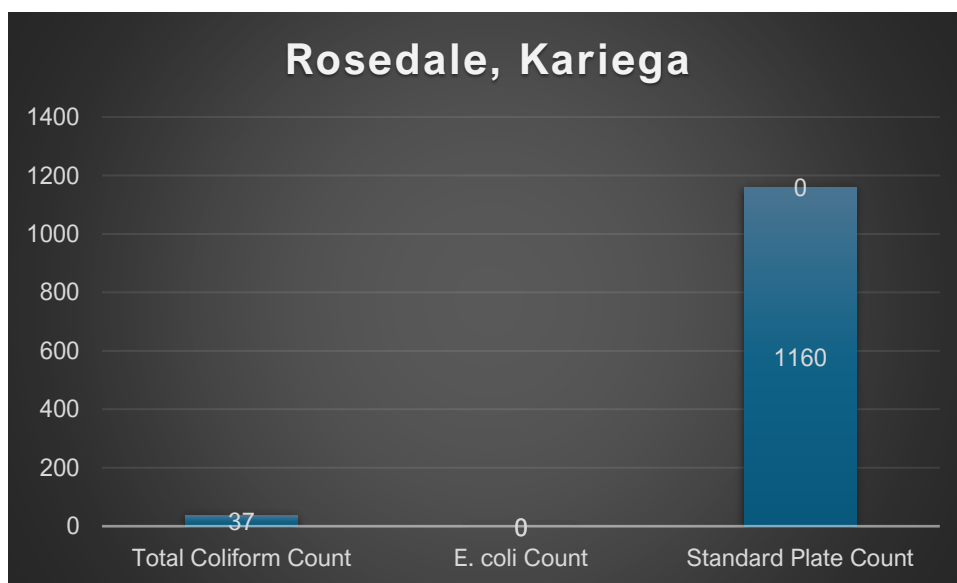
The findings of this recreational facility exceeded the limits for total coliforms and standard plate count. Total coliform concentrations measured 37 CFU/100mL, far greater than the SANS standard requirement of absence or less than 1 CFU/100mL, while standard plate count reached 1 160 CFU/mL, surpassing the limit of $\leq 1\ 000$ CFU/mL. These results clearly indicate that the swimming pool is currently not suitable for recreational use, as the water quality is compromised.

Figure 8: Rosedale, Kariega results.

The absence of *E. coli* is positive but does not mitigate the risk, as other pathogens could be present. Urgent corrective measures are needed.

1. Formally notify residents in the affected areas (Gelvandale, Westering, Malabar, and Rosedale) that the water is microbiologically unsafe and advise against recreational use until further notice.
2. Immediately inspect and service all the water infrastructure supplying of these areas to identify sources of contamination.
3. Implement regular inspections and maintenance of pump stations, and stormwater outlets.
4. Flush, disinfect, and re-sample the affected systems. Isolate the contaminated sections if necessary.
5. Perform rigorous daily sampling and analysis in the affected zones until consistent compliance with South African recreational water guidelines and WHO guidelines is restored over a minimum period.
6. Audit the maintenance, disinfection, and monitoring protocols for the entire water supply network to prevent recurrence.

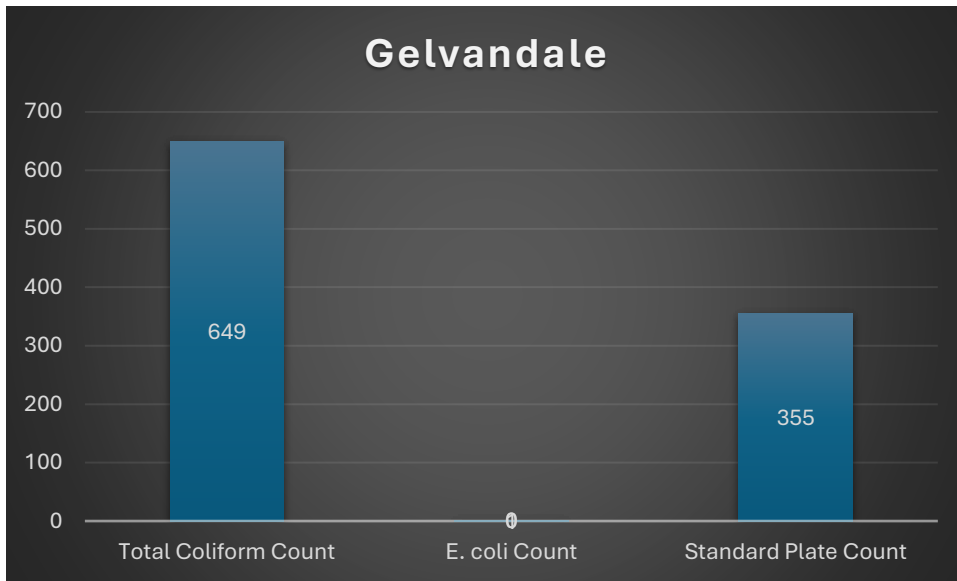
Figure 9: Gelvendale results.

The extremely high total coliform count combined with the confirmed presence of *E. coli* indicates gross contamination and a serious health risk. The fact that the Standard Plate Count is only moderately elevated suggests the contamination may be recent, as these general bacteria have not yet had time to multiply.

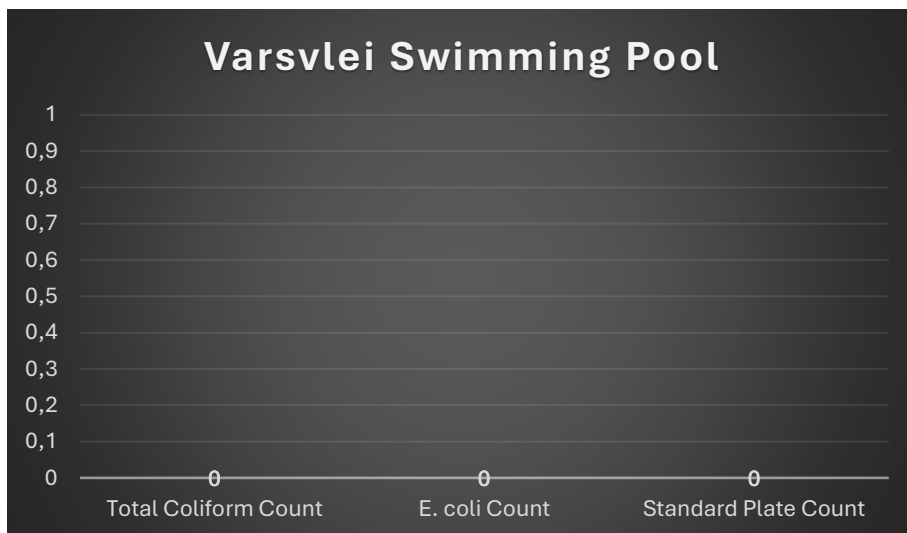
Figure 10: Fully compliant analysis for Varsvlei swimming pool.

This sample met the Target Water Quality Range (TWQR) for all microbiological parameters tested against. The water quality is excellent, indicating effective treatment and a protected distribution system. It poses no detected microbiological health risk and is suitable for its intended use.

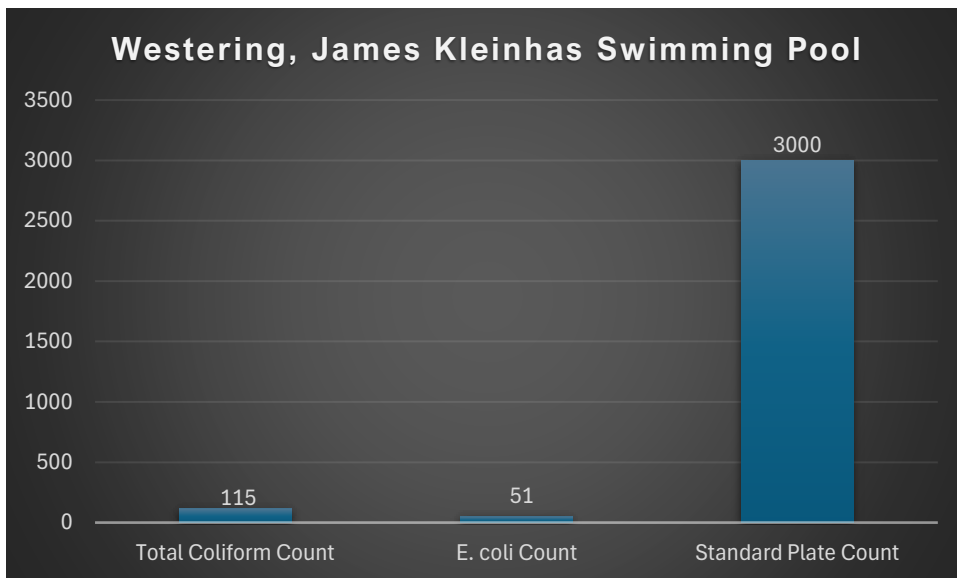
Figure 12: Westering swimming pool water analysis.

This is the most serious result. The confirmed presence of *E. coli* constitutes definitive evidence of recent faecal contamination and an unacceptable acute public health risk. The water must be considered unsafe for any recreational use.

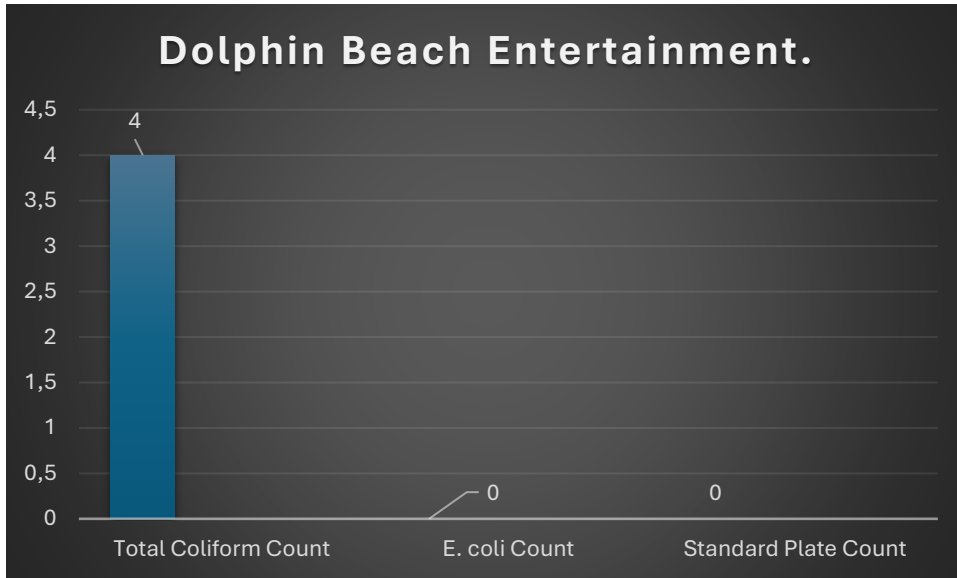
Figure 13: Dolphin Beach Entertainment Water Park.

Dolphin Beach Entertainment is one of the Eastern Cape’s most popular Outdoor Fun Parks. The park features a Raging Waterslide a Mini-Golf Course and a Snack Shack. Situated a few meters from one of the country’s Blue Flag beaches, this pool water sample met all microbiological standards. The low-level detection of total coliforms at 4 CFU/100ml is within the acceptable compliance range and is common in recreational water.
